INVENTIVE: A JOURNAL OF MULTIDISCIPLINARY STUDIES**Volume 4.(1), 21 January, 2022: pp: 1-9**

**Geomorphological Evolution and Disaster Dynamics in Pokhara Valley:
Insights from the 2012 Seti River Flood*****Ramjee Prasad Pokharel****Rajeev Upadhyay****Department of Geography, Prithvi Narayan Campus, Pokhara*****Corresponding authors: ramjeepp@gmail.com***Received 8 November 2021, Reviewed 14 December 2021, Published 21 January 2022***Abstract**

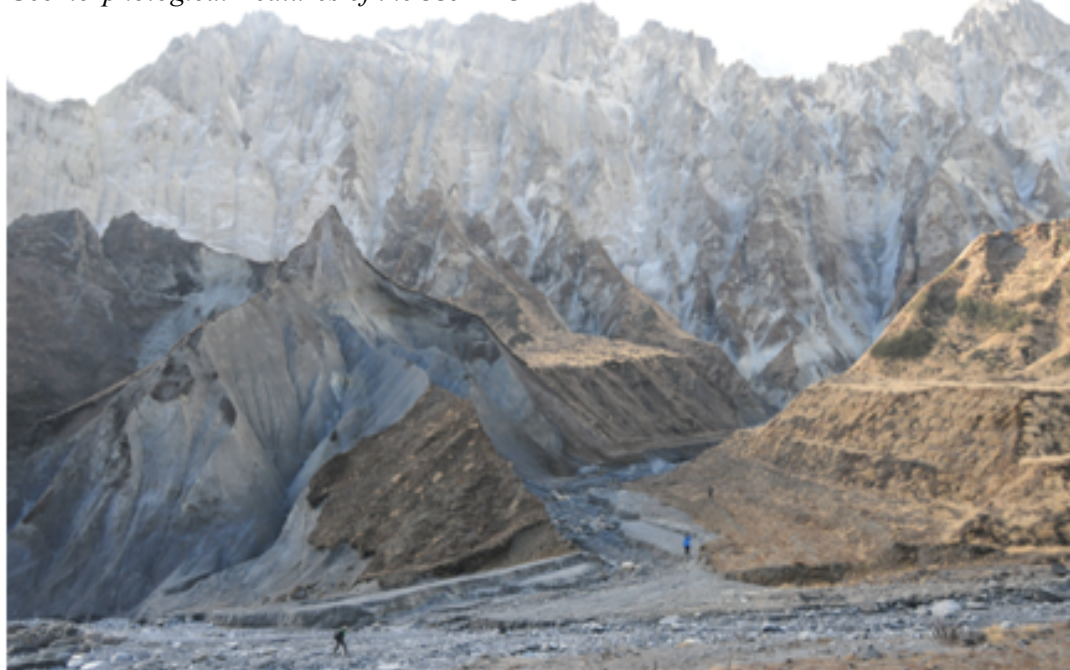
Figure 2

Geomorphological Features of the Seti River

Geological history over times, but occasionally unleashing devastating floods, reminding us of its dual nature (Nepali proverb: The same fire that burns also gives warmth). The Pokhara Valley's flat landscape is a product of long-term geomorphological evolution shaped by glacial activity and the sediment-carrying Seti River. Originating from the southern slopes of Annapurna IV and Machhapuchhre, the Seti and its tributaries (Sandhu and Batase Khola) transported debris and deposited layers of sediment over thousands of years, forming stratified landforms in the basin (Gurung, 1970; Yamanaka, 2007). During the last Ice Age, glacial meltwater carried moraines into the valley, creating the present flat terrain. Natural lakes like Phewa, Begnas, and Dipang remain in areas where flood deposits did not fully reach. Radio-

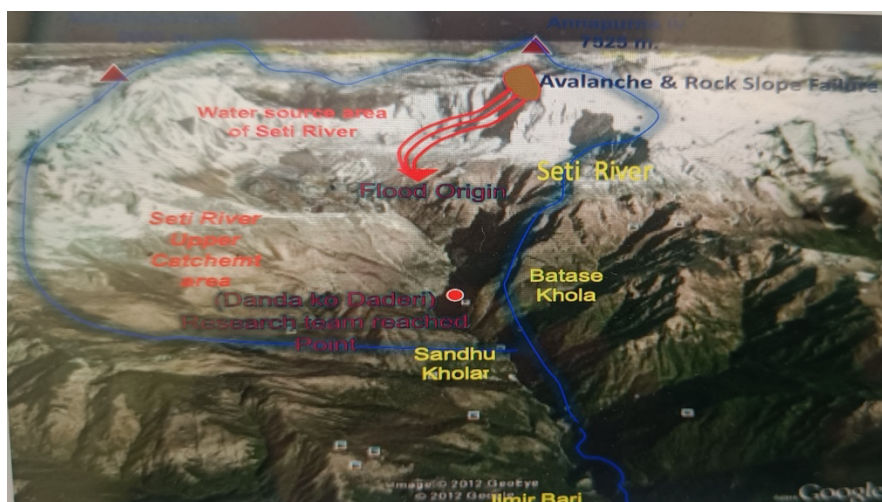
The landslide originated from Annapurna IV, where a rock mass approximately 300 meters wide, 1,300 meters tall, and 30 meters thick collapsed. This massive fall is also supported by aerial photographs taken by Avia Ckobe pilots who captured the event as it occurred.

According to the Himalayan Disaster Report (Kartik 26, 2069 B.S.) photos show dust clouds rising from the rockfall, and the path of the landslide clearly indicates that a large volume of debris was dislodged. NASA satellite imagery taken after the incident confirms that the landslide originated from the glacial area above. As the rock mass fell, it applied pressure to the loose and unstable materials below, displacing and pushing them into the river. The sudden increase in volume caused the Seti to flood downstream.

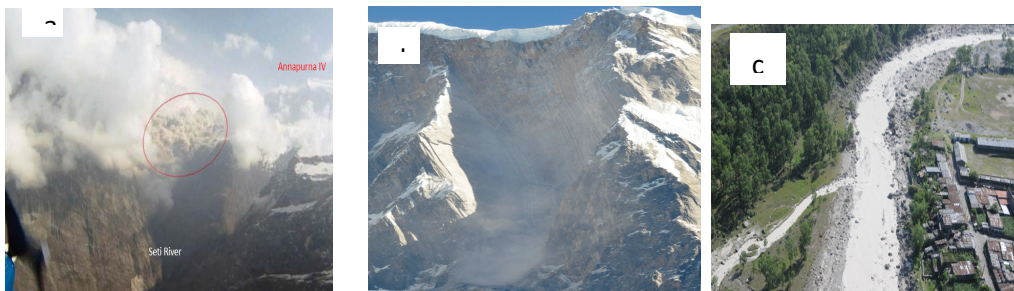
Figure 3:

***Photographic evidence of rockfall and resulting dust cloud from Annapurna IV.
(Slide area a and b and c High-Risk Areas Near the Seti River)***

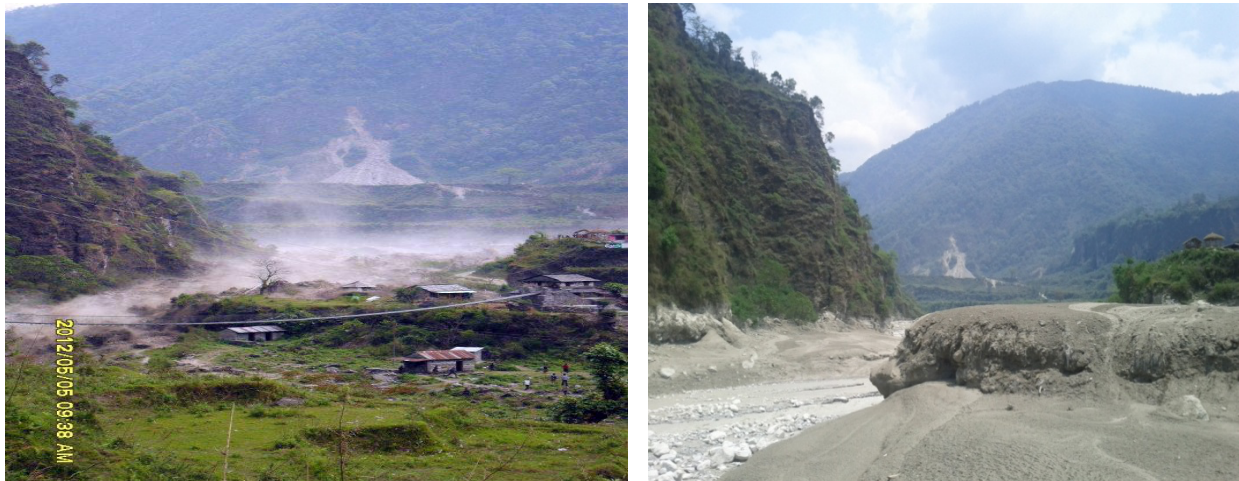
The flood carried a massive volume of sediment and debris from the river's origin through its narrow gorges. Because of its high velocity, the river deposited materials up to 50 meters above the normal riverbank in some areas. The force of the flood eroded the riverbanks, especially near upper Sandhukhola, while low-lying Poche farmlands were entirely covered by sediment. Similarly, farmlands and homes in Sandal were buried. The narrow areas around Poche and Lower Ewang experienced intense erosion, while Kharapani was buried under thick deposits.

The most heavily affected zones were from the confluence of Sandhukhola southward including Gyamirbari, Poche Khola junction, Sandal, Kopuche, and Kharapani where massive deposits of flood debris accumulated. In Poche, the large number of uprooted trees buried in sediment serves as visible evidence of the flood's power.

Figure 4
Kharapani of Kaski, before and after the flood event

From a geographical perspective, the structure of Pokhara and the origin of the Seti River, along with the regular flow of debris and sediment, suggest that the 2012 Seti River flood (Baisakh 23, 2069 B.S.) was part of a natural, recurring process. To reduce future flood risks in Pokhara, a multi-pronged strategy is essential. This includes establishing an early warning center in Kobuche to monitor the fragile Seti River headwaters and enforcing strict zoning laws to prevent settlements in high-risk flood zones. Natural riverbanks should be preserved and reforested, while hazard mapping and geological assessments must guide long-term planning. Public awareness campaigns are crucial for community preparedness. Additionally, infrastructure like retaining walls and vegetation should be used to stabilize erosion-prone areas. A permanent emergency response unit should be stationed in Sandal or Kobuche. Technological interventions such as widening narrow river channels and removing obstructions at chokepoints (e.g., KI Singh Bridge to Ratopahiro) will help improve floodwater flow and reduce damage during future disasters.
